# TECHNICAL BULLETIN

## NUMBER 2021 - 012

**Date:** November 2, 2022  
**Author:** James Howley  
**Subject:** Resetting MiniHub to factory defaults

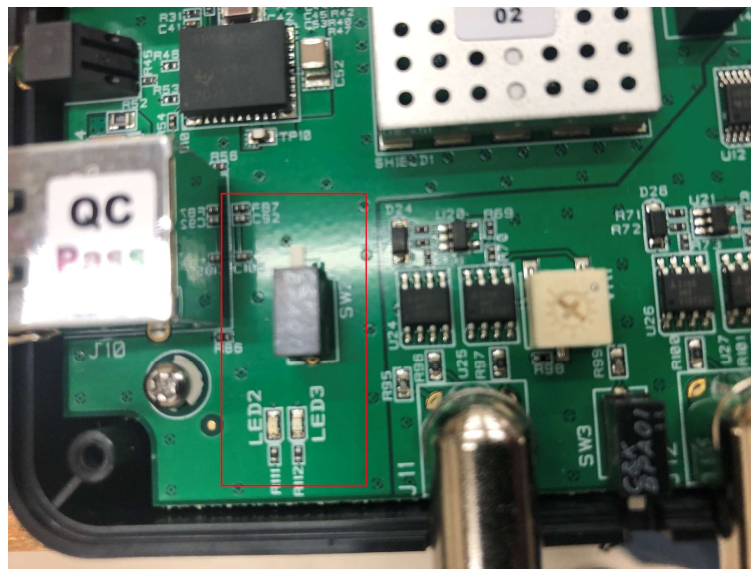
If a MiniHub will not establish communication using the default IP address of 192.168.1.10, a reset to factory defaults may be necessary to resolve this issue.
