TECHNICAL BULLETIN

NUMBER 2022 - 013

Date: November 15, 2022
Author: Kevin Tularam and Zeeshan Ayub
Subject: Resetting Firmware on YSI 4010 Meters

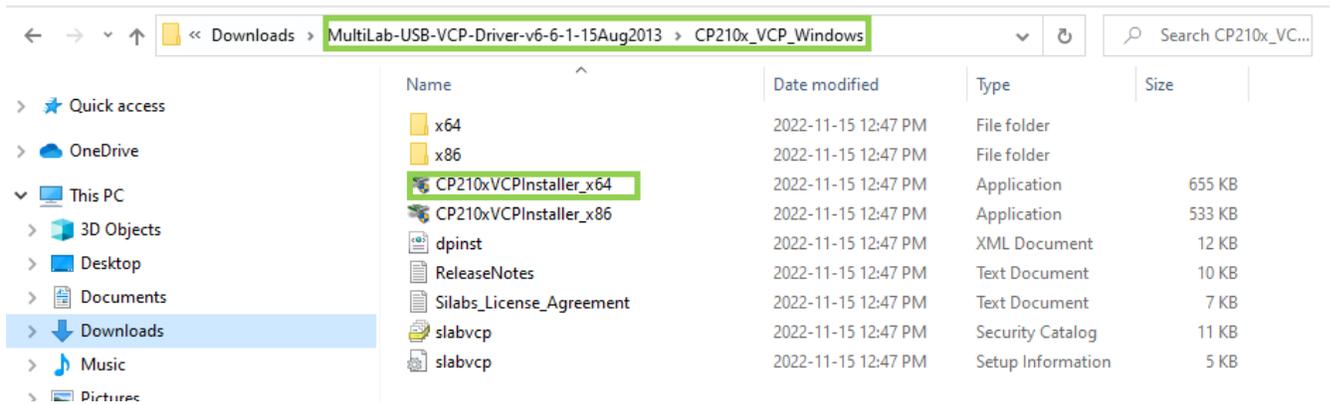
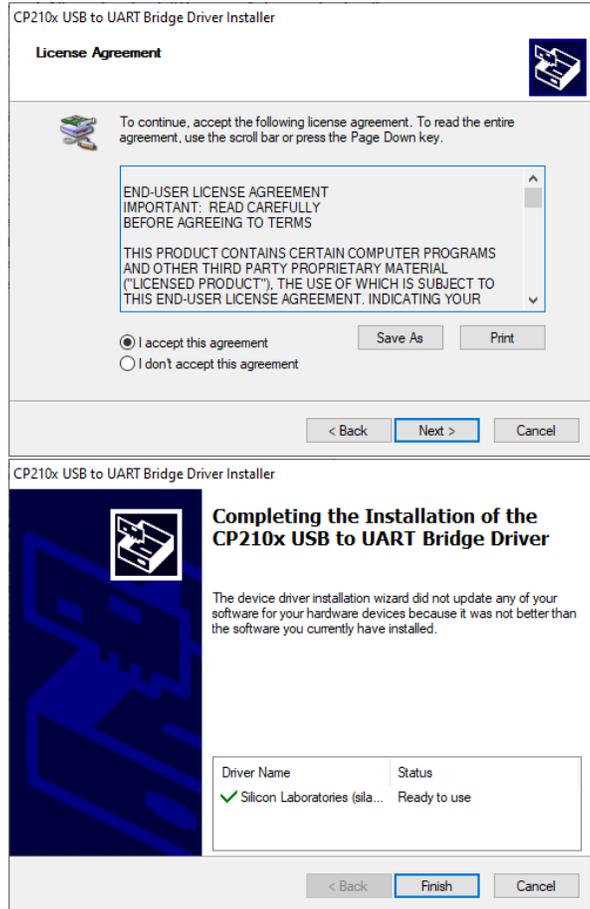
There are instances where YSI 4010 meters do not communicate to BOD Pro, despite the correct COM ports and BAUD Rate, which ultimately requires the meter’s firmware to be reset.

1. Download the following drivers:
 - a. MultiLab USB VCP Driver, found [here](#)
 - b. Firmware Update based on model of meter:
 - i. 4010-1W Firmware Update, found [here](#)
 - ii. 4010-2W/3W Firmware Update, found [here](#)
2. After downloading the MultiLab USB VCP Driver, Right-click “CP210xVCPInstaller_x64” and select “Run as Administrator”
